THE 55-WINDOWED PALACE

- Conservation for the future without causing pain to the past -

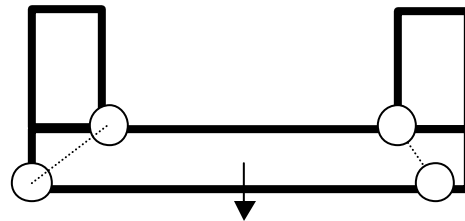
The 1934 earthquake caused failure to the building and the *Chota* floor on the main south wing gave way. The earth motion that led to the damage was north-south and the top roof fell forward to the south. The side wings and the two lower floors of the south wing survived. Apparently the verandah on the inside and its lean to roof also fell. The nature of the failure can tell that the floor ties did not give way saving the floor over the bedroom intact. This should mean that the tie system at the base of the *viman* window also did not fail. It should be a matter to note that the failure occurred on that part of the building which was basically a timber framed floor weighted with a heavy roof. Stresses would be more in upper floor, but with the nature of construction, this floor should also have behaved stronger. The structural engineering at the time of construction of the palace was already armed with the jointing innovations for floors⁶ and corner *viman* windows and frame action obtained through the system of constructing the long multi-bayed *viman* window spanning from corner core to corner core. The reason for the failure therefore should be sought at the roof joints. The diagram shows these critical areas, where the joints must

have been considerably weak at the time of the earthquake. These joints were strong enough in the past, but 220 years and a major earthquake was too much. Action of age and water on the joints may explain the damage better than the earthquake action per se.

The leaning walls are facts and the problem is real calling for 'emergency interventions' approach. But since the 'emergency' has extended for so long, starting the works that form a part of the full scheme but which help stop further aggravation of leaning tendency should qualify as emergency intervention. The recommended approach is to *house in* the vertical timber ties (wall stiffeners by removing the brick veneer and decorative door and window heads) and introducing similar uprights on the outside at the back pressing against the wall on the verandah. Wall plates will be used behind the cornice ties all along the length of the wall and pressed in by the uprights. These wall plates will be tied to the outermost structural frames of the door and windows. Alternatively hidden internal posts may be introduced linking the window and door system to the plates. A temporary timber boxing is constructed inside the room with wall plates to avoid movement of walls during the tightening process⁷. The vertical posts are tightened with horizontal timber tie spanning the width of the building and placed underneath the *Mata* floor and over the *Chota* floor. The objective is not to straighten the tilt but to stop further tilt through unitary action. It may require some way of counter balancing at the base of the verandah floor and the upper *chota* level.

Except the internal boxing all the emergency works will be retained in the structural conservation action, which would be mainly reconstructing the inner timber core frames in the corner stair wells. The staircases will be repositioned. The *Chota viman boxing system* will be integrated with the core structure. During this process the jointing and sways of structural posts and lintels would be done. I do not recommend that we try reverting back the window to original by increasing the projection as this may add to counter balancing needs and overstress the leaning out wall.
