## The Reconstruction of the Bhagavati Temple at Naxal

- Prof. Sudarshan Raj Tiwari, PhD

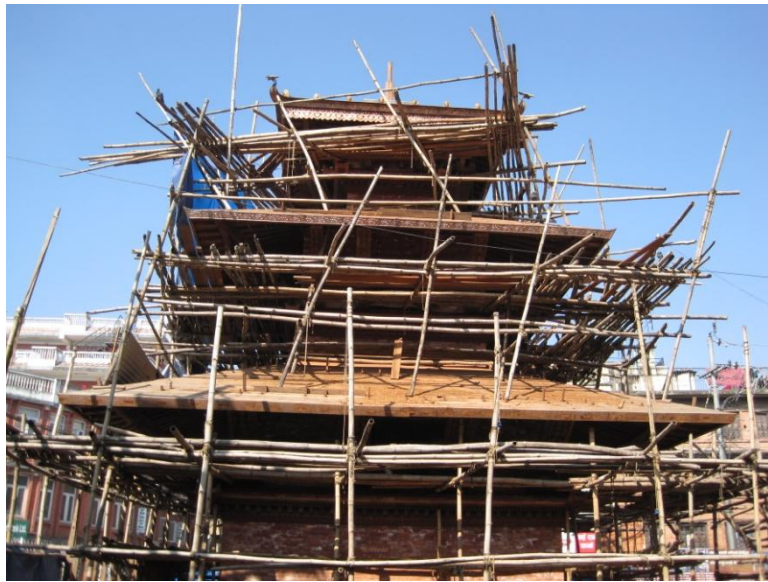
**Fig 1: Work in Progress, Feb 26 2011**

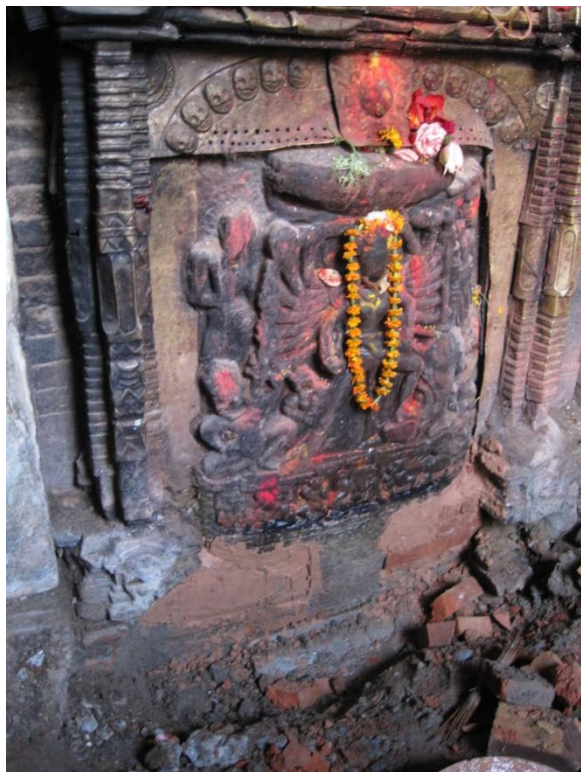
**Fig 2: The monolithic dowel of the image of Bhagavati**

excavating about half a meter below the carved portion of the image, showed a monolithic taper dowel standing on a piece of stone, which appears to have settled. The lower stone could well be part of the original '*jalahari*' type of support stone used to house the dowel.

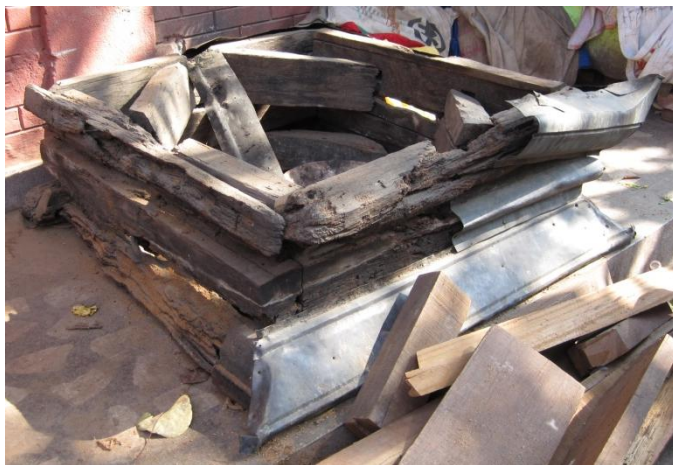
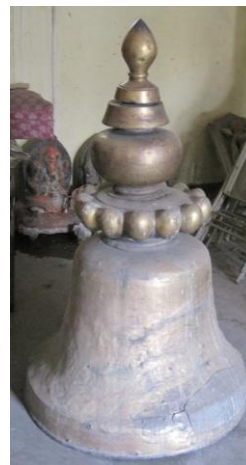
**Fig 4 & 5: The extent of damage of the base structure of the Gajur and the Gajur (right).**

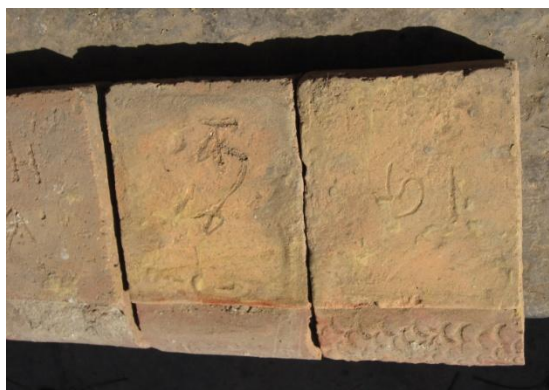
**Fig 6: The numbered Baa-appa cornice bricks**

in the back side of the sanctum walls just as a token honour to the position of the technical committee! However, all woodworks of the Ga-jhya and struts in all the three floors were cleaned and reinstalled back in the reconstructed temple as per original state. Only the undamaged patterned bricks (*baa-appa*) of the cornice were reused. The committee also agreed to house within the body of the wall a new timber frame, uprights and ties, to strengthen it against the action of earthquakes.
