THE 55-WINDOWED PALACE

- Conservation for the future without causing pain to the past -

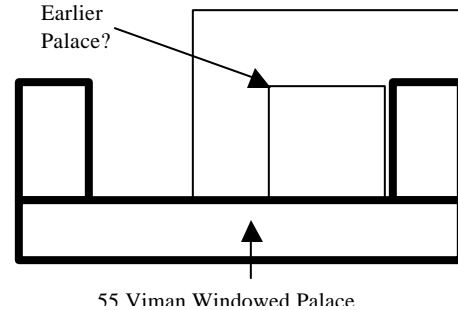
A critical study of the construction and repair history should be an important input to developing a conservation strategy for the Palace as this can clarify the architectural, structural and aesthetic nature and intent of the original builders. It is known that the construction period spanned over two decades¹ (1702-1722 AD) and Bhupatindra Malla apparently sited it over earlier structure that was a square shaped courtyard unit built by his

father. The south-east corner of both the old and the new palace was apparently the same. This can be surmised from several facts: (i) The foundation remains below the floor along the N-S axial line of the building (Gutschow: 1993), (ii) the nature of the courtyard outline, (iii) the three bayed *Viman* window on the inside of the east wing and (iv) *thyasafu* records that the foundations of the new palace were laid by his father (which apparently meant use of the earlier palace foundations on the eastern half of the palace) and (v) varying foundation footing pattern observed in the building. This would mean that some incongruities in foundations and ground floor in eastern half of the palace may be said to be 'original and authentic'. Lack of foundations in 'Investigation trench # 1' explains this systemic difference at foundation level. Similarly overall asymmetrical (Ds+TW+Dc+TW from left to right in west wing) disposition of doors and windows on the outside of the west wing could be a mirror image of the original east wing. The difference in detailing at door and window lintels level and the thick wall in southeast corner, as shown by the current study, must mean that the original asymmetry of the east face and other features of this corner were changed further during later interventions. The nature of the *Viman* window in first floor of the east wing on the inside and the disposition of door and *Tiki*-windows below it should suggest that these are older than the 1702 construction. The location of *viman* window in first floor shows that the earlier courtyard unit was two storied. Therefore, only the *Chota* living room of the 55-window palace and the western wing construction were all new to start off with.
